DOT/FAA/RD-92/8

Performance of Insulated Pavements at Newton Field, Jackman, Maine

Maureen A. Kestler
Richard L. Berg

May 1992

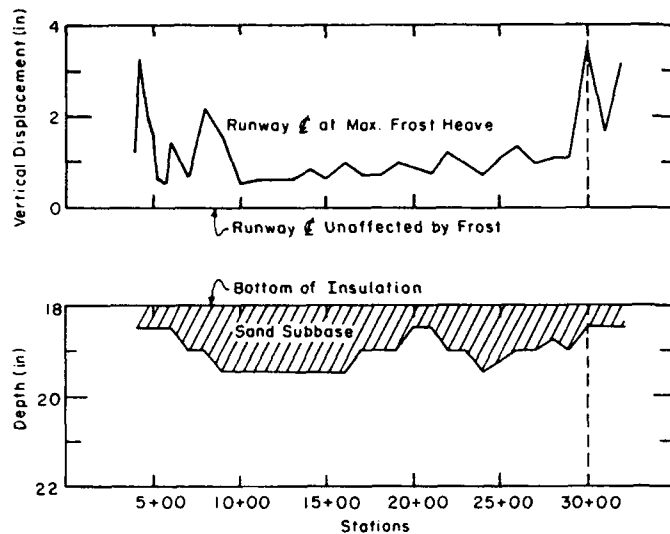
Figure 11. Profile of frost-heaved centerline and corresponding depth of sand subbase, March 1990.

insulated pavement at Nichols Road was approximately 1 in. While the maximum frost heave along most of the runway was only slightly greater than that observed at the test sections, substantial frost heave occurred in three localized areas: station 4+00 to station 6+00 exhibited approximately 3 in. of frost heave; stations 8+00 to 9+00, approximately 2 in.; and stations 30+00 to

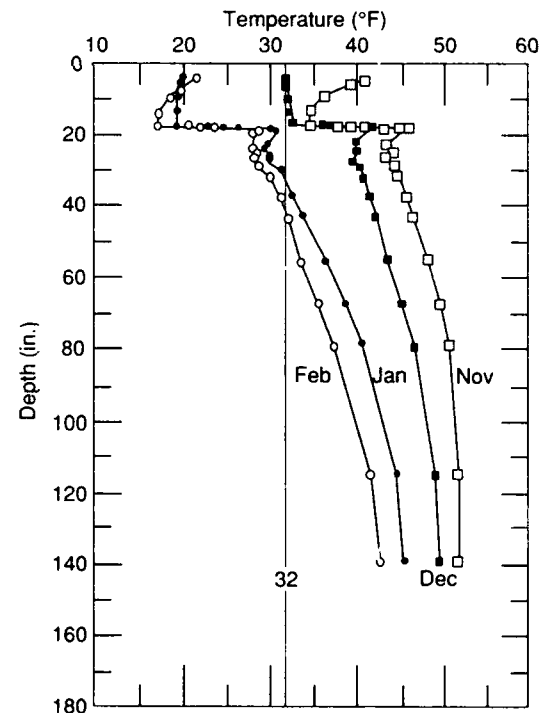
d. Subsurface temperatures at Newton Field, station 4+50, winter 1987-1988.

A distinct temperature discontinuity occurs immediately beneath the insulation on the runway (Fig. 13d). Two vertical thermocouple assemblies, one located both in and above the insulation and the second located entirely below the insulation, are separated horizontally by approximately 5 ft. It is believed that the temperature discontinuity between the thermocouple assemblies is caused either by damage to the insulation or by the horizontal separation of the insulation panels. The problem probably occurred during construction. Evidence of this problem was encountered during construction near stations 4+50 and 8+00. At both locations, trucks, bulldozers, and other construction traffic caused a large subgrade "flow" that in turn raised the insulation. Under

direction of the resident engineer, the insulation was removed, the subgrade was removed to the desired depth, and the geotextile, insulation, and base course were all replaced.

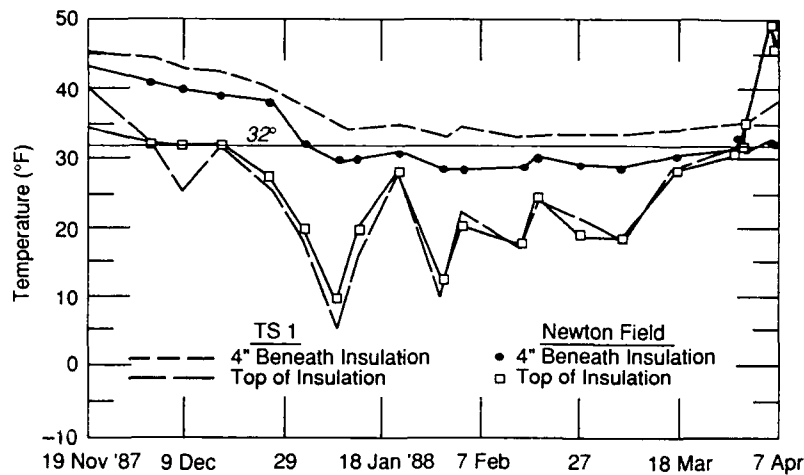
Figure 14. Comparison of temperatures above and beneath the insulation at Newton Field and in test section 1.

The difference in insulating ability of the insulation at the two pavement sites is also seen in Figure 14. Although the temperatures at the top of the insulation at each site are comparable, 4 in. beneath the insulation the temperatures differ substantially and fairly consistently over time. For winter 1987–1988, the 32°F isotherm never penetrated to this depth at the test sections, but at a comparable depth at the runway, the temperature remained below 32°F for nearly three months. This performance was the same for all three winters during which subsurface temperatures were obtained at both sites.

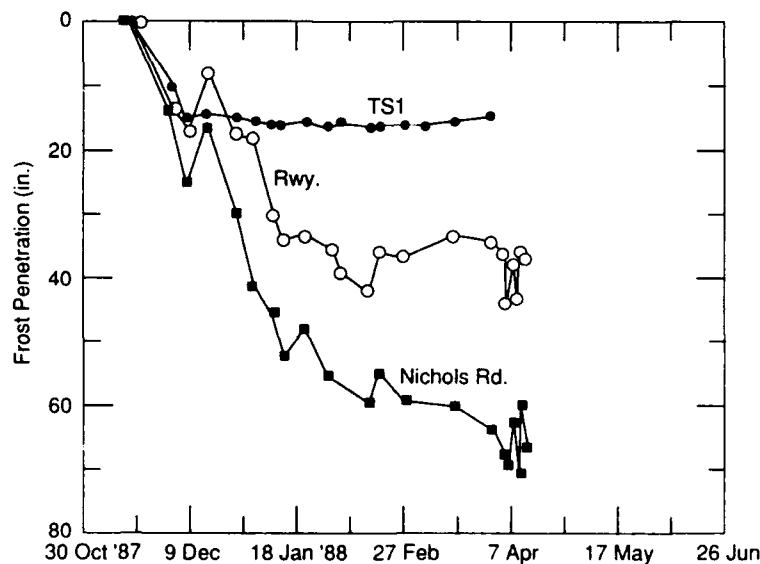
Figure 15. Progression of frost penetration with time, winter 1987–1988.

The progression of frost penetration with time is shown in Figure 15. For the 1987–1988 winter, the insulated pavement at the runway (station 4+50) allowed approximately 2 ft of frost penetration beneath the insulation. Although appreciably less than at noninsulated Nichols Road, the actual frost depth far exceeded all estimates. The unexpected frost penetration beneath the insulation on the runway during winter 1986–1987 constituted the primary reason for installation of the test sections in 1987. In contrast to the limited effectiveness of the insulation at the runway, the insulation at test section 1 prevented frost from penetrating into the subgrade. While Figure 15 is based upon 1987–1988 data, the curves are representative of each year; frost never

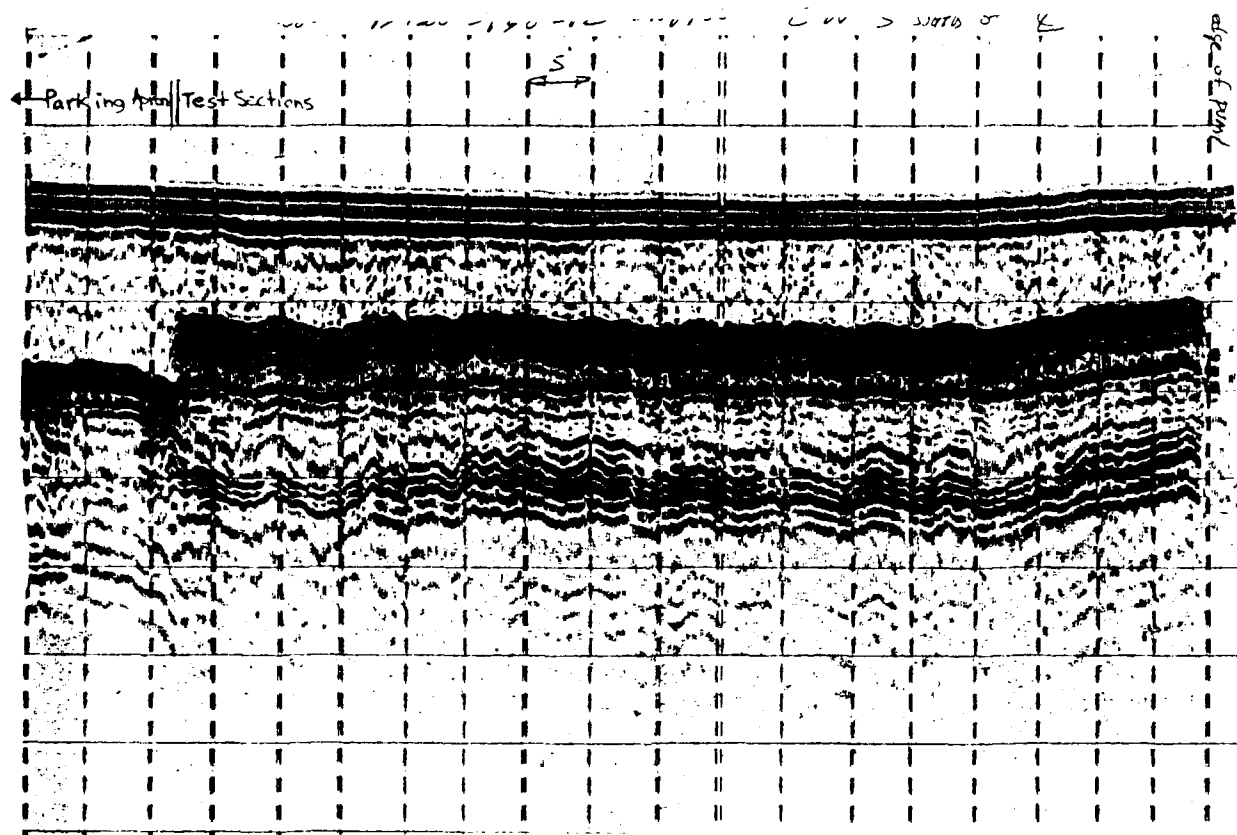
a. Centerline profile at test sections.

The transducer was pulled manually along the centerline of the test sections; the corresponding radar record is shown in Figure 22a. The unequal depths of the insulation at the parking apron and test sections are indicated by the discontinuity in the second set of dark bands.

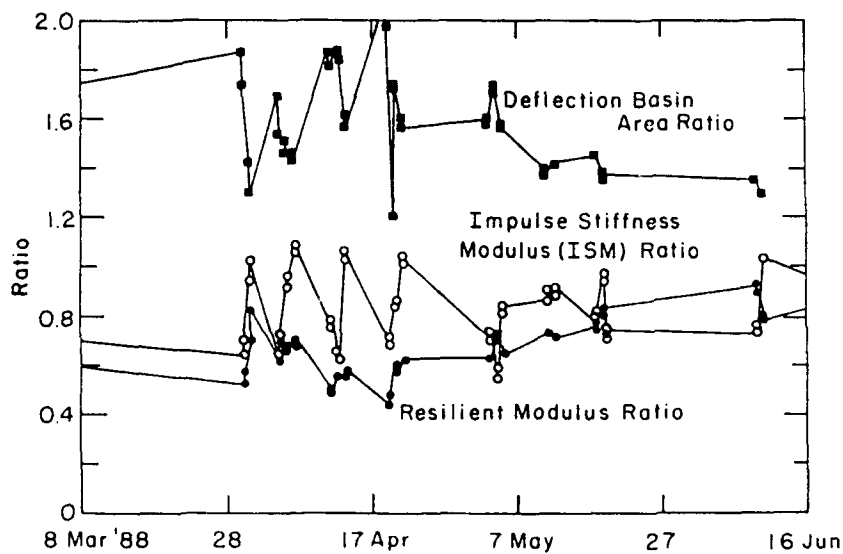
a. Deflection basin area ratio, resilient modulus ratio, and ISM ratio.

Figure 26 contains similar data for station 4+50 on the Newton Field runway. The figure expresses area, impulse stiffness modulus (ISM), and resilient modulus in terms of ratios to initial (15 Oct 1987) reference

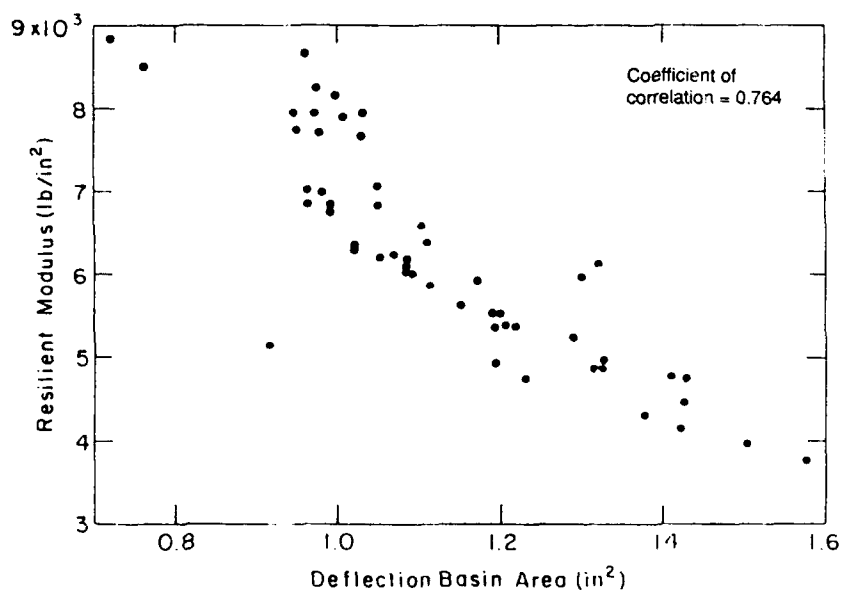
b. Correlation between deflection basin area and resilient modulus.

apply only to conventional noninsulated pavements. A reasonable correlation between deflection basin area and resilient modulus is seen in Figure 26b.

While conventional pavements typically peak and recover with time, as shown in Figure 26b, the deflection basin area of the insulated pavement remains larger than the conventional pavement, yet relatively constant
